Title: Multi-Site Fatigue Testing and Characterization of Fuselage Panels from Aging Aircraft Structure

## Multi-Site Fatigue Testing and Characterization of Fuselage Panels from Aging Aircraft Structure

Sandeep R. Shah<sup>1</sup>, Todd B. St John<sup>1</sup>, Ian L. Pryce, Jr.<sup>1</sup>,  
Gregory A. Shoales<sup>2</sup> and James M. Greer, Jr.<sup>2</sup>

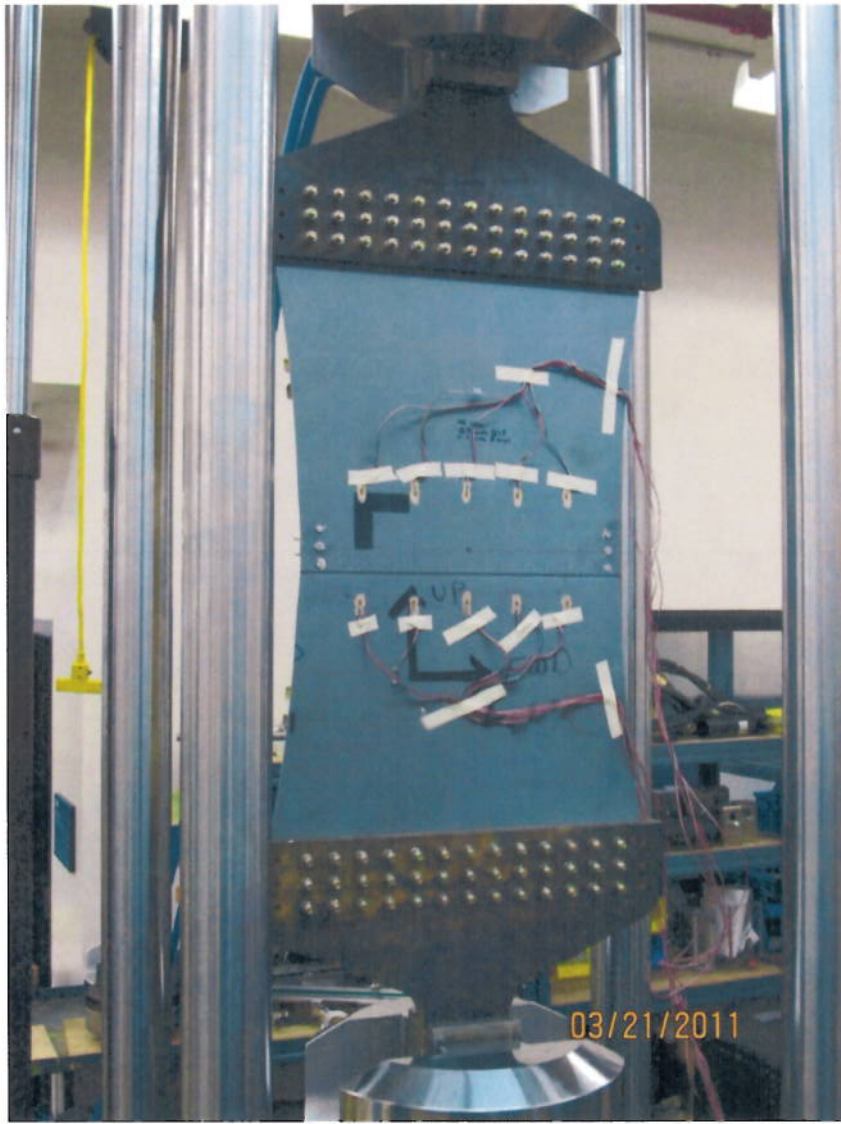
Figure 3: Photo showing the specimen mounted in the grips and test frame. Strain gage locations and replaced edge rivets are visible in the photo.
